United States Department of the Interior

BUREAU OF LAND MANAGEMENT

Date: 08/20/10
To: Minerals Files UTU-69800, UTU-69812
From: Ted McDougall, Geologist
Subject: Surface Management Site Inspection, Denison Mines (USA) Corp, La Sal Mines (Pandora – UTU69800/M0370012; LaSal, Snowball and Beaver– UTU69812/M0370026), San Juan County, Utah.

Date of Inspection: 08/16/2010
Time of Inspection: 9:00 A.M.
Participants: Ted McDougall, Danny Flannery
Legal Description: T. 29 S., R. 24 E., Section 01
Claimant/Operator: Denison Mines
Bond Amount: \$175,811 for Pandora Mine
Date of Last Bond Review: 10/19/09 for Pandora Mine

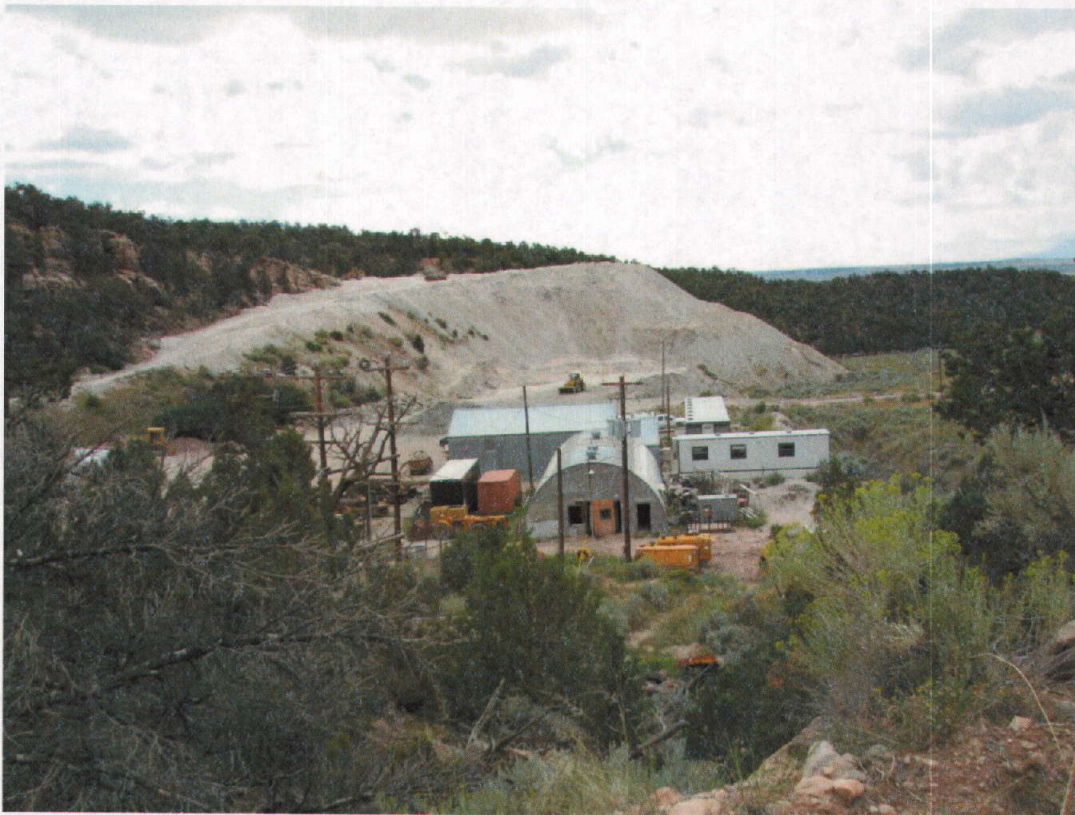
The Pandora Mine is the largest mine site in the LaSal Mines Complex. Denison's contractor, Reliance Resources, is mining the Pandora. According to Danny Flannery, Reliance's contract has been scaled back due to current uranium prices. Mine production has been cut from approximately 7,500 tons/month to 3,500 tons/month. The mine has been downsized from 20-25 employees to an existing crew of 5-7.

Pandora Mine. Top – Overview of mine; Bottom- Office, shop, dry and warehouse.

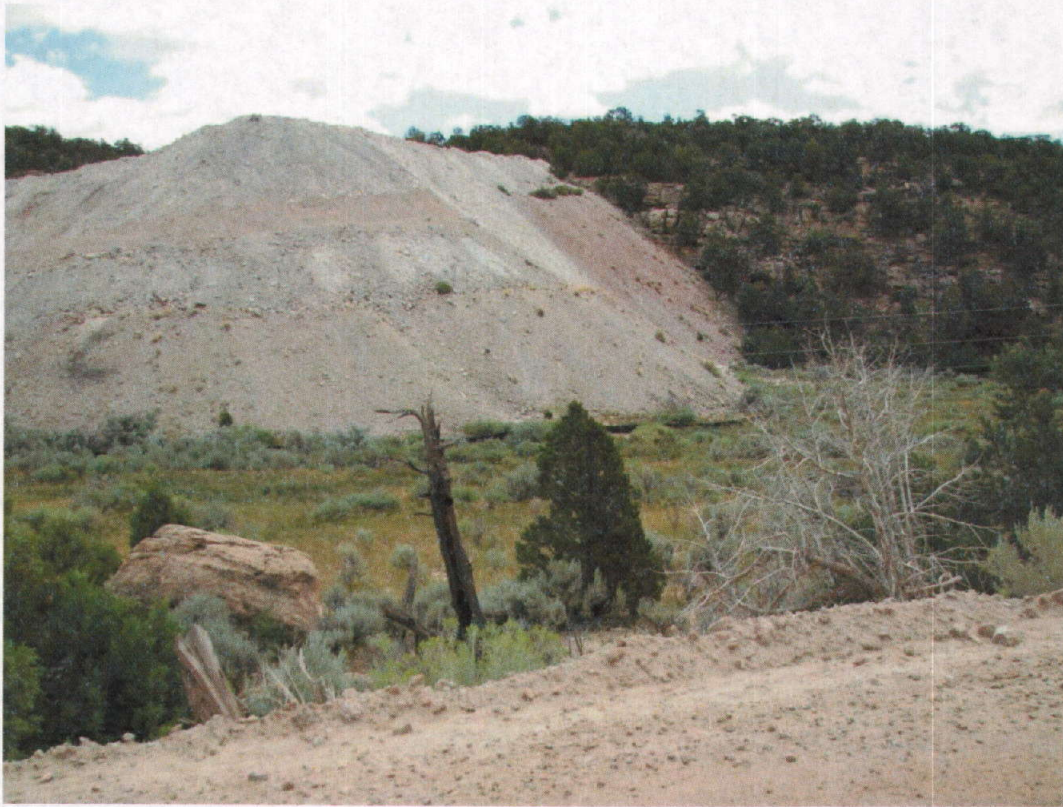
Waste Rock Disposal - The waste rock dump needs to be expanded to accommodate continued mine production. However, the toe of the dump occupies the full extent of the permit area. To avoid getting outside the permit area, the waste rock is simply being stacked higher on the top of the dump. There is some concern that the dump could become unstable if slopes are over steepened. However, I didn't observe any excessive erosion or other signs of slope instability. The slope of the dump appears to be maintained at the material's angle of repose. The bigger problem for the operation may be the loss of available space for waste rock disposal. As the dump gets higher, the surface area on top of the dump becomes smaller and the haul route becomes steeper. There is also a concern for proper storm water control because of the dumps encroachment against and onto the canyon rim. Expansion of the dump would alleviate the concern but, extending the dump beyond its current footprint requires a Plan Modification. In December 2009, the Moab Field Office received a Plan Modification for the LaSal Mines Complex which includes the needed dump expansion at the Pandora Mine. Approval of that modification is still pending. After reviewing the situation on site, it appears that it may be possible to pile some additional waste rock at the south end of the ore pad. This would not require a Plan Modification. However, sufficient area would have to be maintained for stockpiling ore and getting haul trucks in and out. Danny said he would follow-up with the contractor to see if there is room to accommodate temporary waste rock storage in that area. Should it become necessary, an alternative may be to haul waste rock from the Pandora Mine to the dump at the LaSal Incline.

Pandora Mine. Top – Waste rock dump; Bottom – View from top of dump looking toward the area of proposed expansion. Note silt fence at toe of dump.

- Denison Mines should consult with its contractor at the Pandora to determine if there is room to accommodate some interim stockpiling of waste rock on the far south end of the ore pad, adjacent to the existing waste rock dump. Should it become necessary, an alternative may be to haul waste rock from the Pandora Mine to the dump at the LaSal Incline.

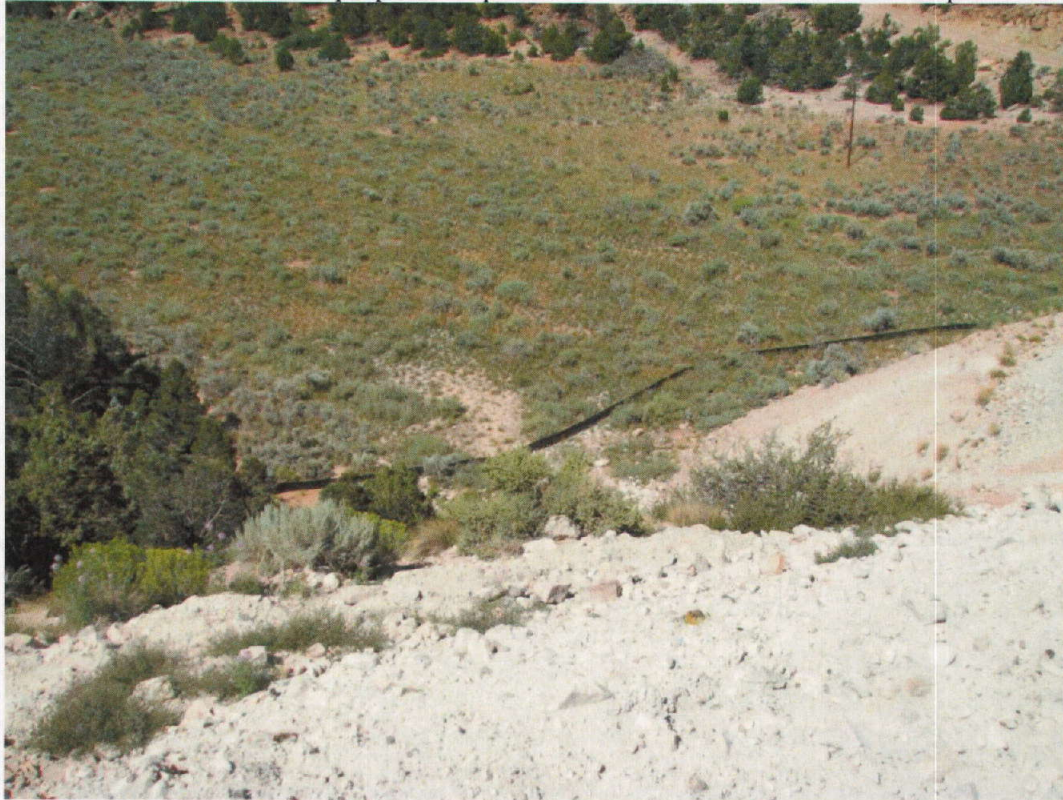
Dump expansion will necessitate re-route of the natural drainage which requires a Stream Alteration Permit from the State of Utah. A silt fence has been installed along the toe of the dump. However, no catchment basins or diversion ditches for storm water were observed. These structures should be included in Denison's Storm Water Pollution Prevention Plan for the project.

No topsoil stockpile(s) from the historic operation was observed. This will become an issue for reclamation. The valley fill material underlying the area of proposed expansion should be a good source of suitable growth medium and provide some relief in meeting reclamation needs. The full depth of this material should be excavated and stockpiled as a condition of dump expansion.

- Denison Mines should complete both concurrent and interim reclamation of the pad area at vent 3-09 (Pandora #12)
- The valley fill material underlying the area of the proposed Pandora Dump expansion may be a suitable source of growth medium for reclamation. Denison Mines should consider excavating the full depth of this material and stockpiling it for future reclamation use. The BLM should consider the handling of this material in its review of the proposed dump expansion.

- Unless previously included, Denison's Storm Water Pollution Prevention Plan (SPPP) for the project should include catchment basins to contain surface run-off from disturbed areas, including all of its waste rock dumps.

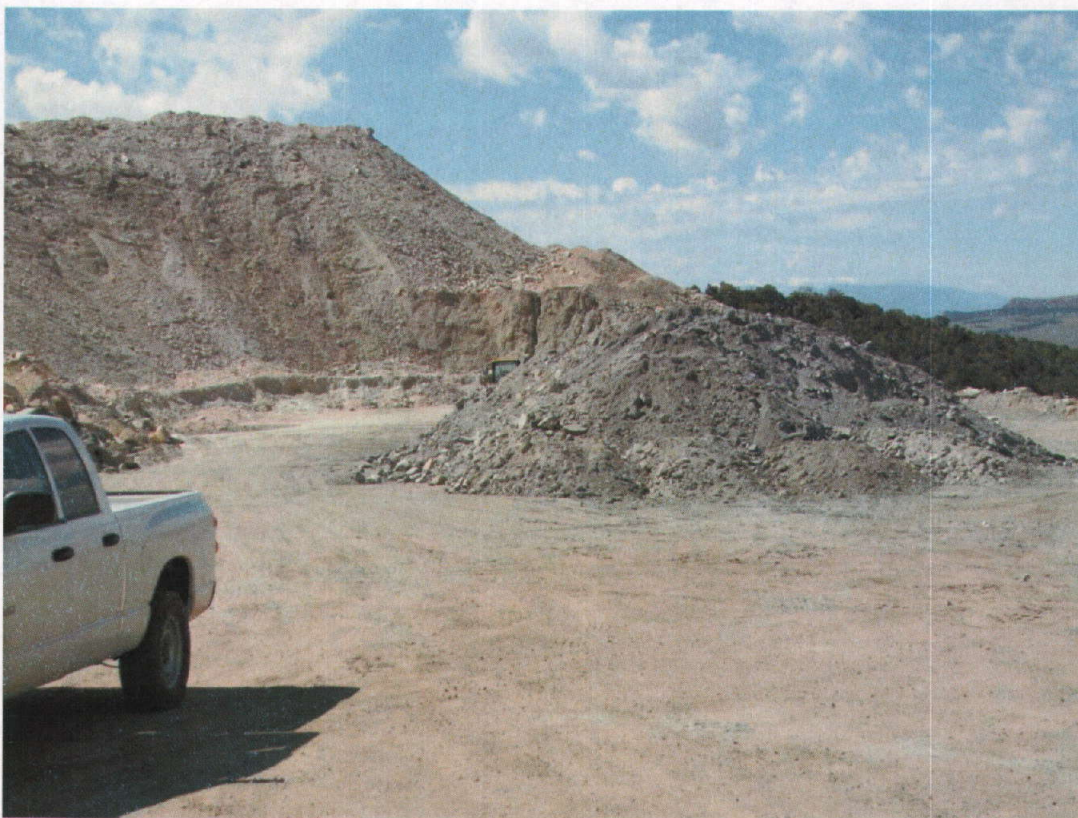
Ore pad at the Pandora Mine. Note possible area for interim storage of additional waste rock just beyond loader.

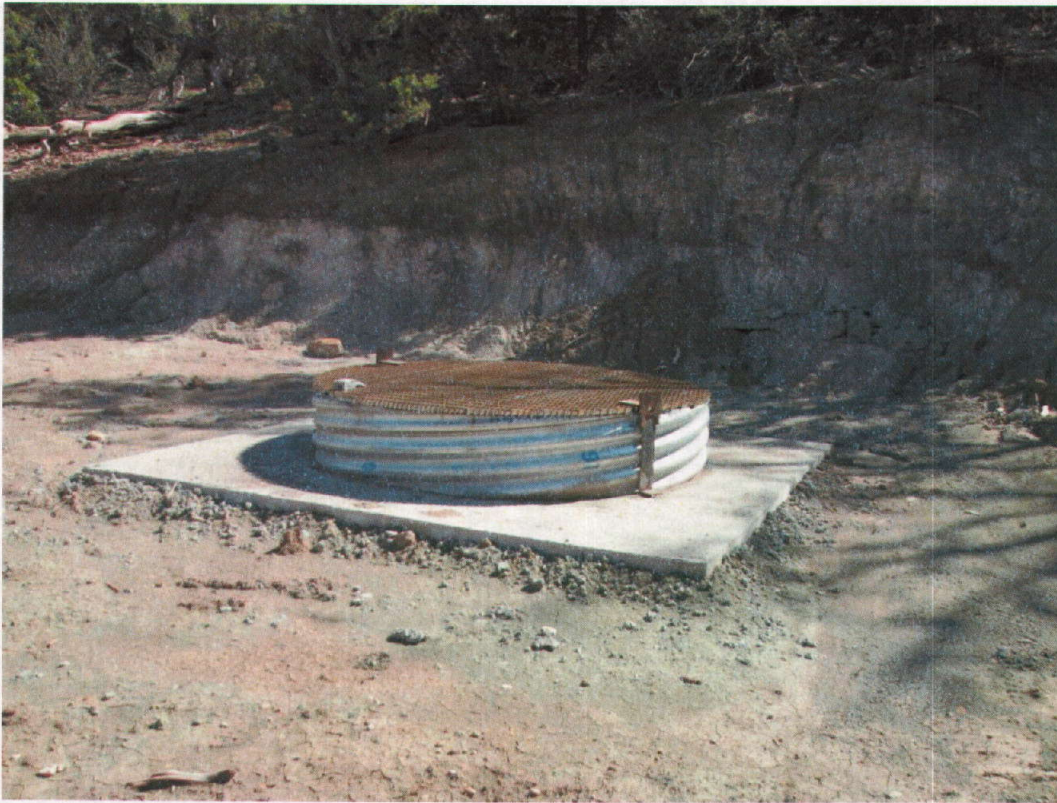
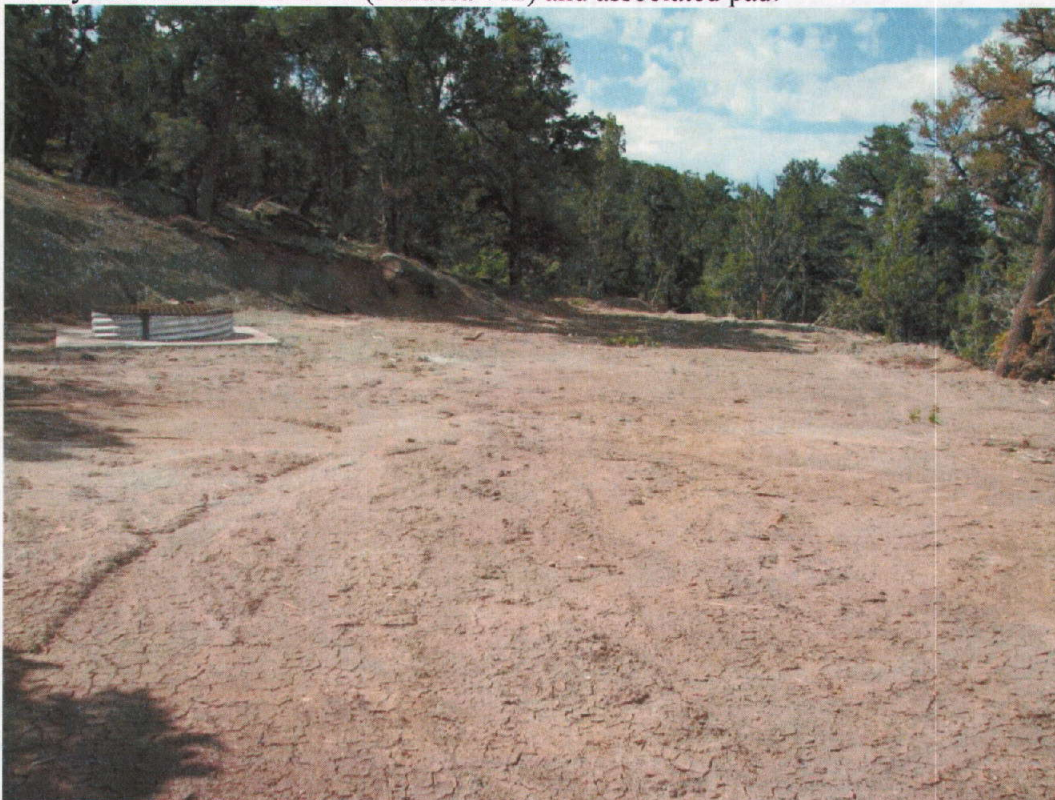
Danny and I visited the newly constructed vent 3-09, referred to by Denison as Pandora #12. A cut/fill pad has been constructed in the slope. A maximum cut of 8 feet occurs directly behind the vent. Total disturbance is estimated to be less than a ¼ acre. The vent hole is located on the northeast side of the pad, opposite the fill slope. The 6-ft borehole is lined at the surface with a galvanized culvert extending approximately 14 inches above a small concrete pad. The fan is located underground so there is no fan housing and diffuser at the surface. A steel grate is secured over the

opening. The disturbed area is larger than needed for future access and maintenance purposes so I talked to Danny about doing both concurrent and interim reclamation on site. The area south of the vent should be reclaimed. Concurrent reclamation can be done at that location by bringing the fill material back to the approximate slope contour and then seeding. The remaining area should have interim reclamation work done by dressing the western fill slope, pulling the trees back over the site and then seeding. Topsoil was not stockpiled on site as part of construction. Therefore, site reclamation should be monitored and if necessary, Denison could be required to apply soil amendments during final reclamation.

Newly constructed vent 3-09 (Pandora #12) and associated pad.

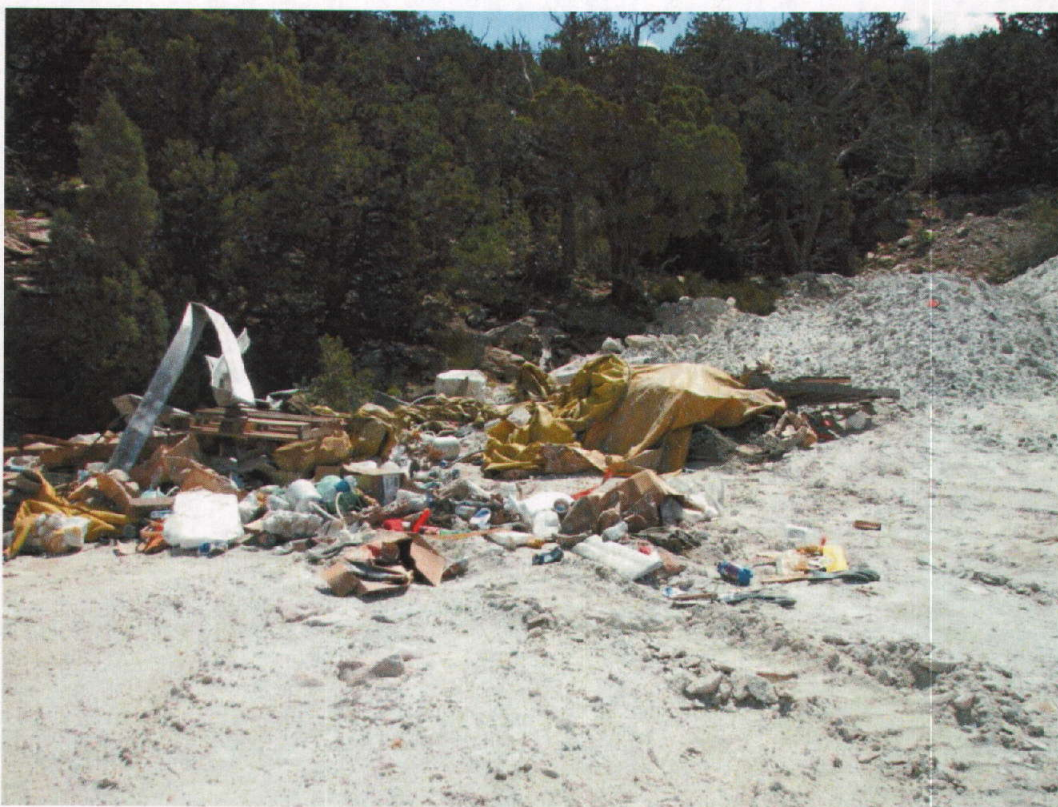
Other – A pile of discarded mine debris including, brattice, pallets, chain link, and common trash was located on top of the waste rock dump. We noted that the on-site trash container was nearly empty. We immediately went to the mine office and Danny talked to the mine foreman about the incident. He stressed that disposal of trash in the waste rock dump was not an acceptable practice. Before we left the site, a loader was dispatched to clean up the site.

Pandora Mine. Top - Trash dumped on the top of the waste rock pile; Bottom – nearly empty trash container.

- Denison Mines should continue to monitor its waste rock dumps to ensure that all trash is placed in the intended trash containers. All trash should then be hauled off site to an authorized disposal facility.

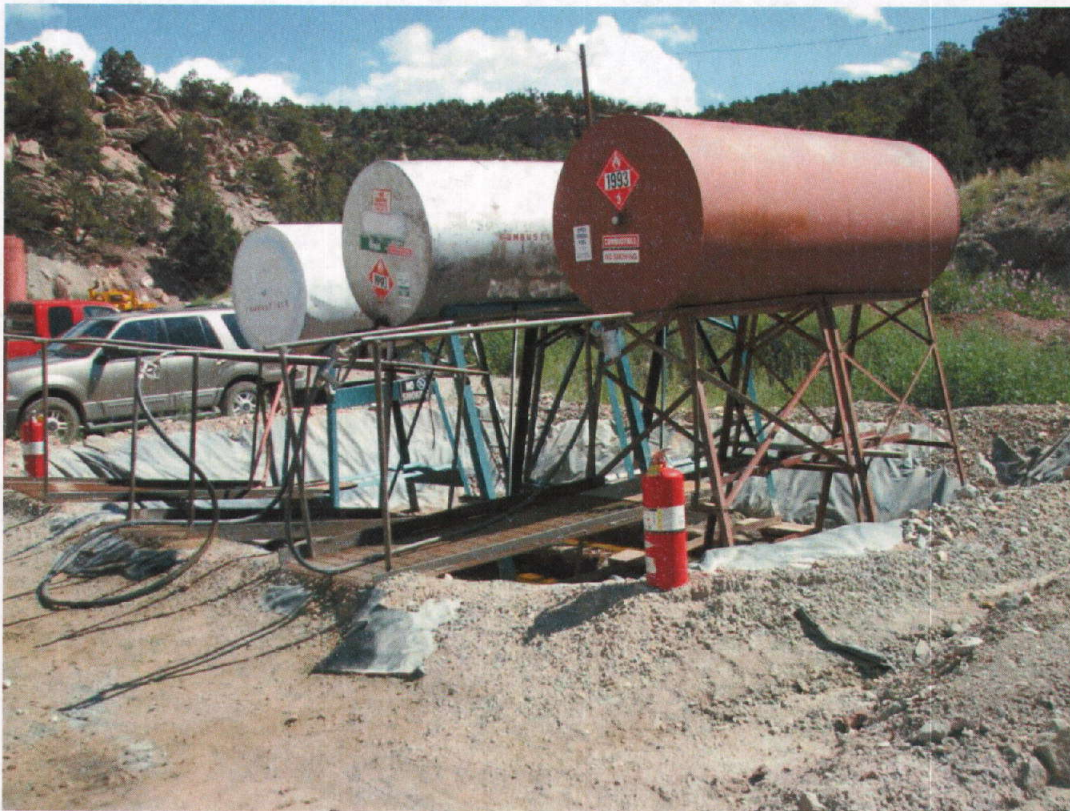
Three fuel storage tanks were observed on site. The tanks are contained by berms and a synthetic liner. The containment is designed to hold at least 1 ½ times the volume of the largest tank.

Pandora Mine. Top – Fuel storage tanks within containment area; Bottom- Mine portal.

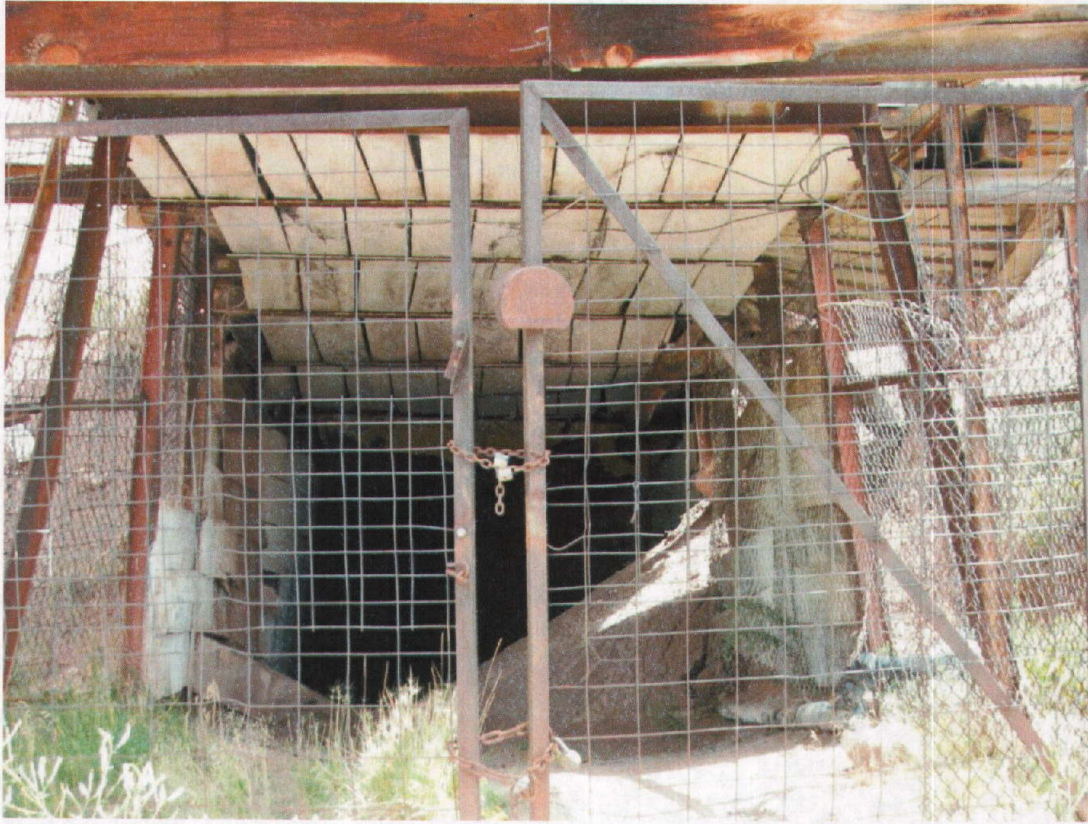
The Snowball Mine is located a short distance up the canyon from the Pandora Mine. The mine is currently idle. The portal and mine adit provides intake air for the Pandora and is also used as an alternative escape route. The mine portal is secured with a locked gate. A silt fence has been installed around the toe of the old waste rock dump. However, similar to the Pandora, no catchment basin for storm water was observed.

Snowball Mine. Top – Locked gate at mine portal; Bottom – Waste rock dump.

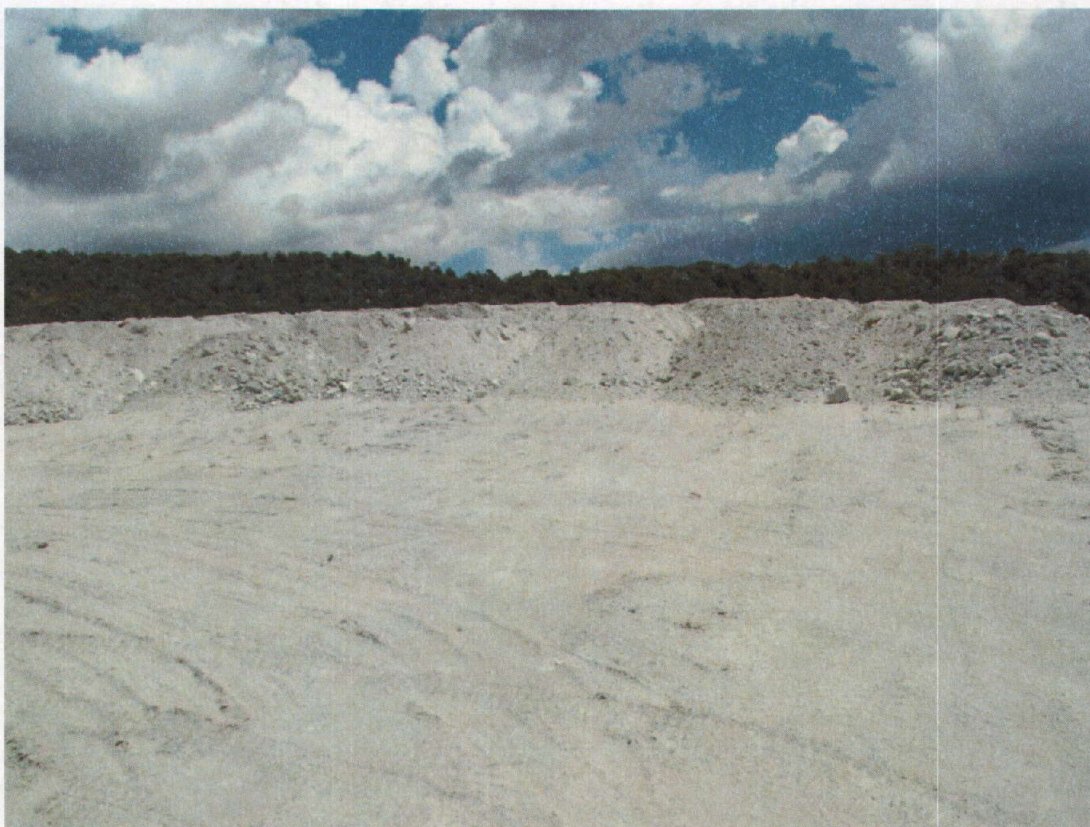
Uranium ore is currently being produced at the Beaver Shaft. Unlike the other mines in the LaSal Complex, the ore is hoisted to the surface through a shaft. Mine facilities occur on both private and BLM land. Based on a map prepared by Denison Mines, it appears that the east waste rock dump is entirely on BLM as well as a portion of the west dump. As with the other mines visited, no catchment basins were noted at the dumps to contain storm water runoff.

Beaver Shaft. Top – Top of east waste rock dump; Bottom – Black bear feeding on cattle carcasses near bottom of east waste rock dump.

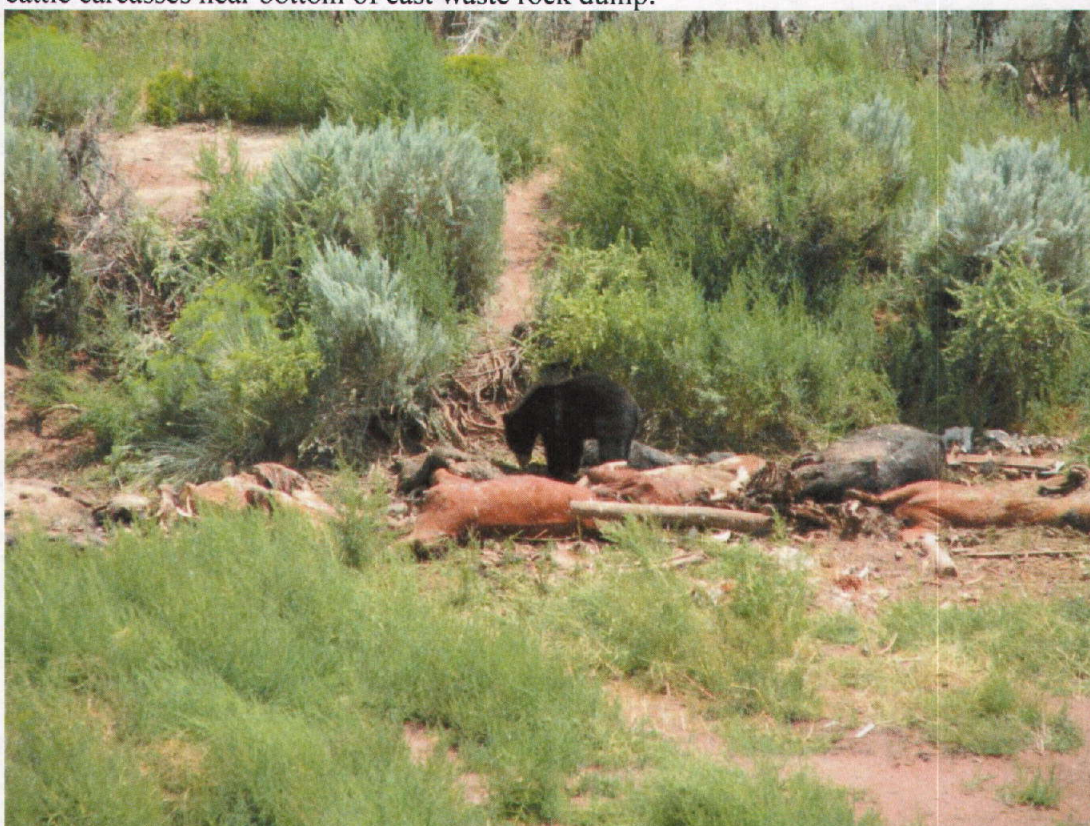
While visiting the east waste rock dump we observed a black bear feeding on a number of cattle carcasses just beyond the toe of the dump. According to Danny, the adjacent land owner uses the site to dispose of cattle that die during winter or occasionally throughout the year. The carcasses are not being disposed of in a pit but are scattered on the surface. Danny thought there may be up to 20-30 carcasses but he always understood the site was on private land. Based on Denison's maps, it appears the carcasses are being disposed of on BLM administered surface.

- Unless previously authorized, the Moab Field Office may want to visit the east waste rock dump of the Beaver Shaft to determine if cattle carcasses are being disposed of on BLM surface.

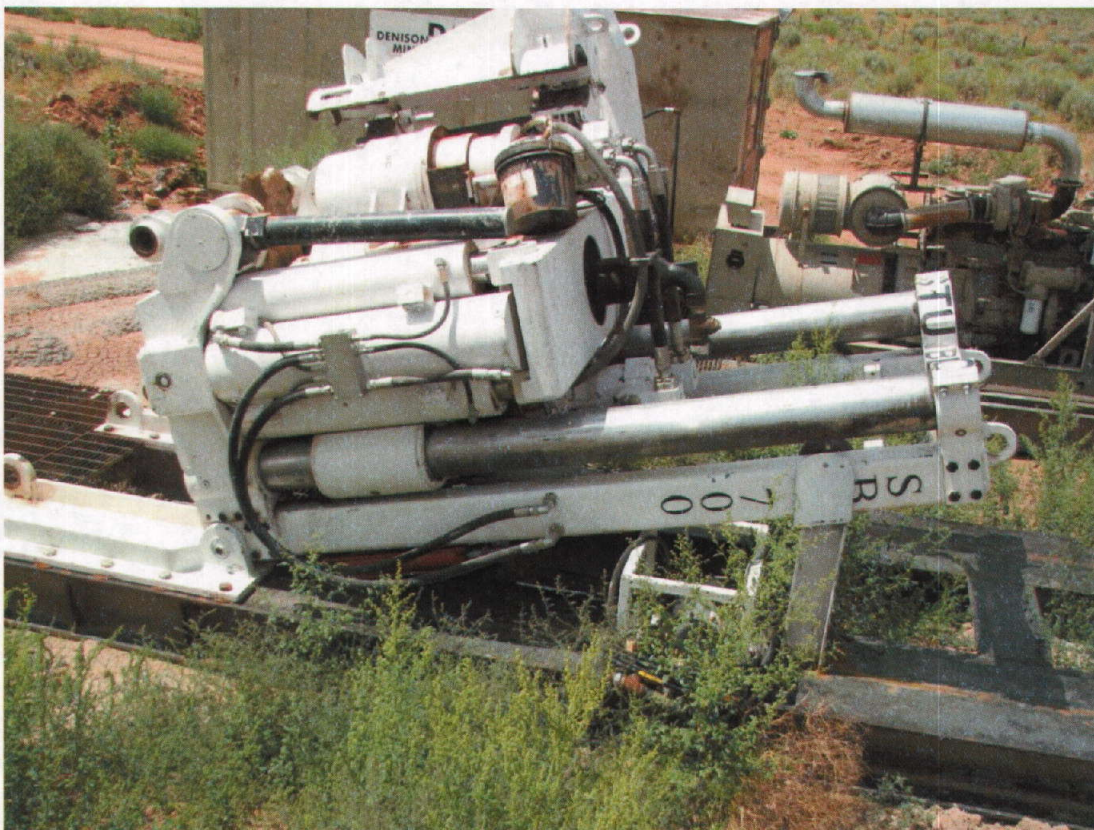
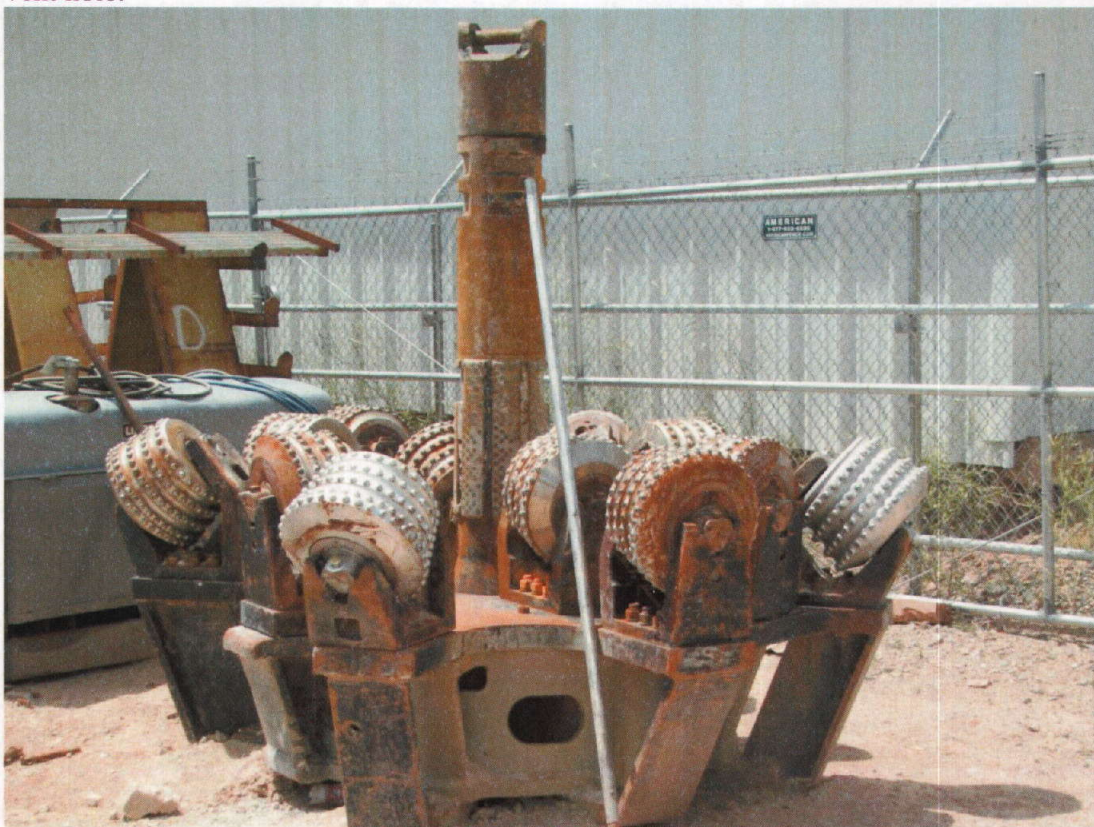
the orebody for future development purposes. While visiting the Beaver Shaft, Danny showed me the site of its recently failed vent hole operation where the ground collapsed and Denison lost the entire raise-boring machine down hole. The site is on private land.

Top – Raised-boring machine. Bottom – 8'ft head for raised-boring machine. Denison lost a similar machine when a site near the Beaver Shaft collapsed while boring a new vent hole.
